Assessment of Dam Safety of Coal Combustion Surface Impoundments

Indianapolis Power & Light Company

Eagle Valley Generating Station

Draft Report

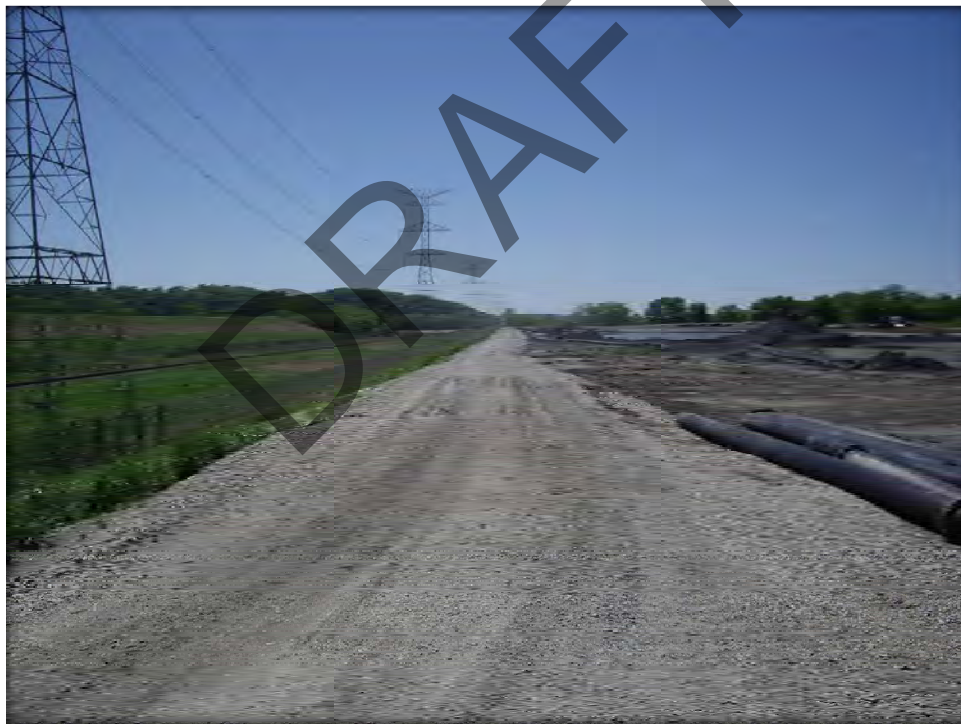
2. Pond A – East embankment crest looking south.

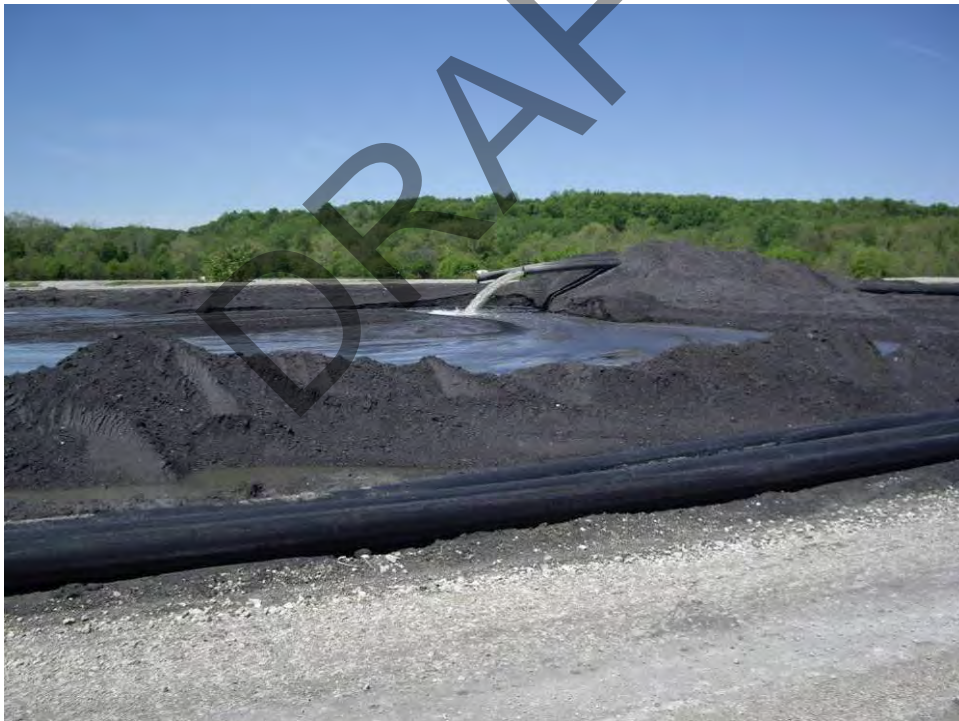
Two (2) 10-inch-diameter High Density Polyethylene (HDPE) pipes sluice CCW waste into Pond A (Photo 6). In addition, a third 10-inch-diameter HDPE pipe sluices plant wastes into Pond A (Photo 10). Pond A is used as the primary settling pond. Floating booms were installed in the pond to direct flow and increase the settling time in the pond. Pond A is connected to Pond B by two (2) 30-inch-diameter Corrugated Metal (CMPs) with an invert elevation of El. 626 (Photo 28, 29 and 30). At the pipe inlets, there is a floating boom wrapped around the inlets and vertical pipe T's are connected to the ends to serve as a hood to reduce the potential for surface debris from clogging the pipes. IPL staff stated that a low spot in the crest in Pond A is an emergency overflow spillway (Photo 28). The spillway is approximately 50 feet wide with the crest at El. 628. This "emergency spillway" is not included on any design plans.

6. Overview of two 10-inch-diameter HDPE discharge pipes into Pond A, looking northwest.

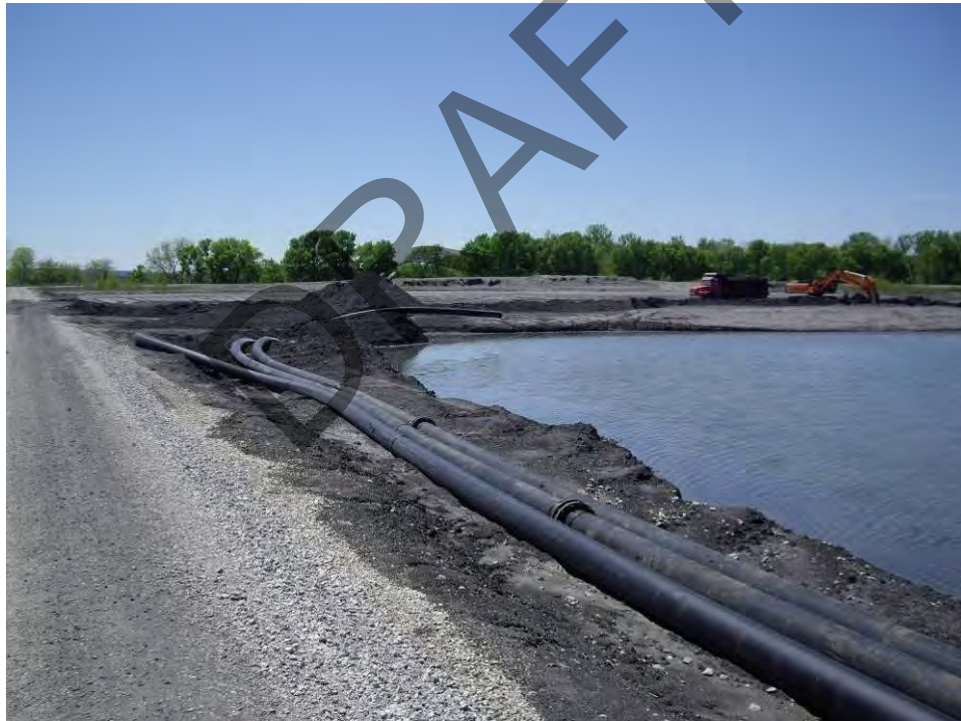
8. Overview of three 10-inch-diameter HDPE discharge pipes into Pond A, looking southwest.
Note two right-most pipes are disconnected.

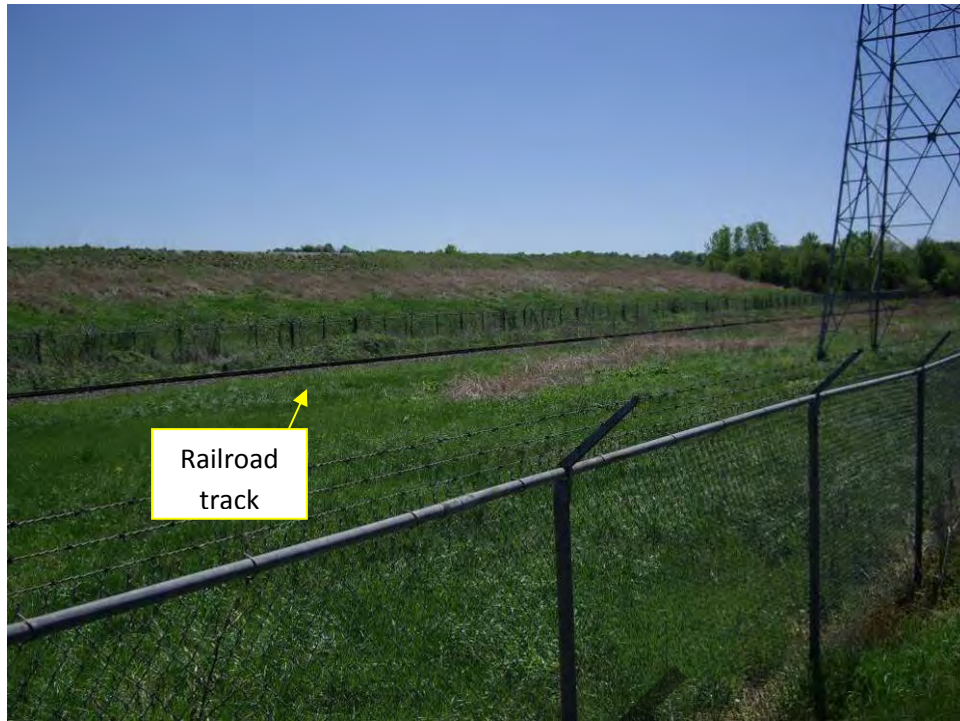
9. Overview of Pond D west embankment exterior slope from toe of Pond A east embankment. Note change in vegetation type at the three vertical expansions.

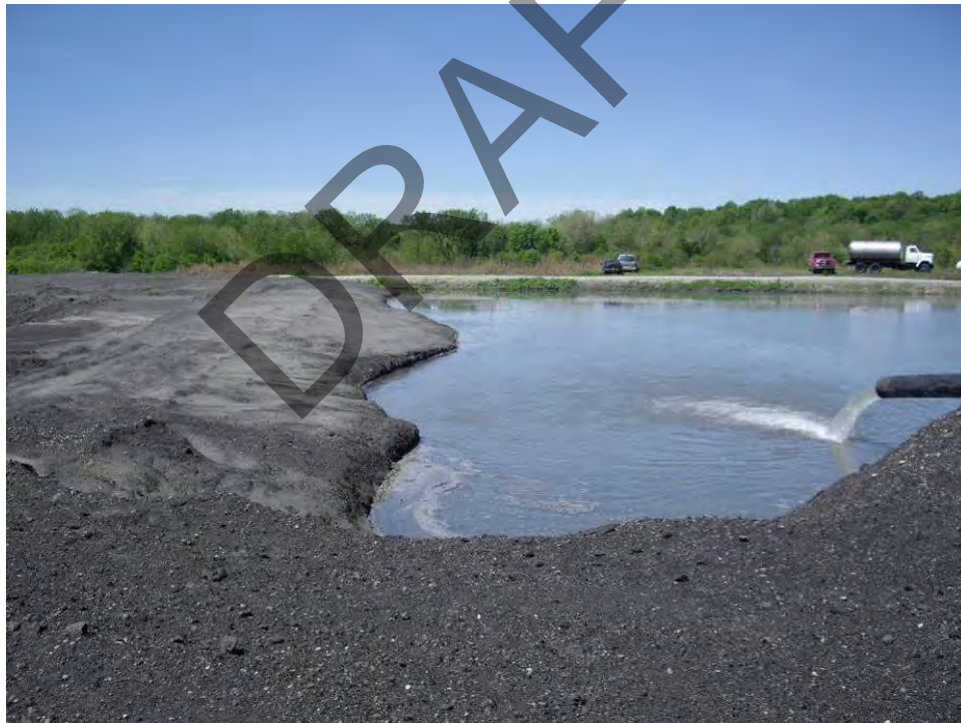
10. Overview of 10-inch-diameter HDPE discharge pipe into Pond A, looking west.

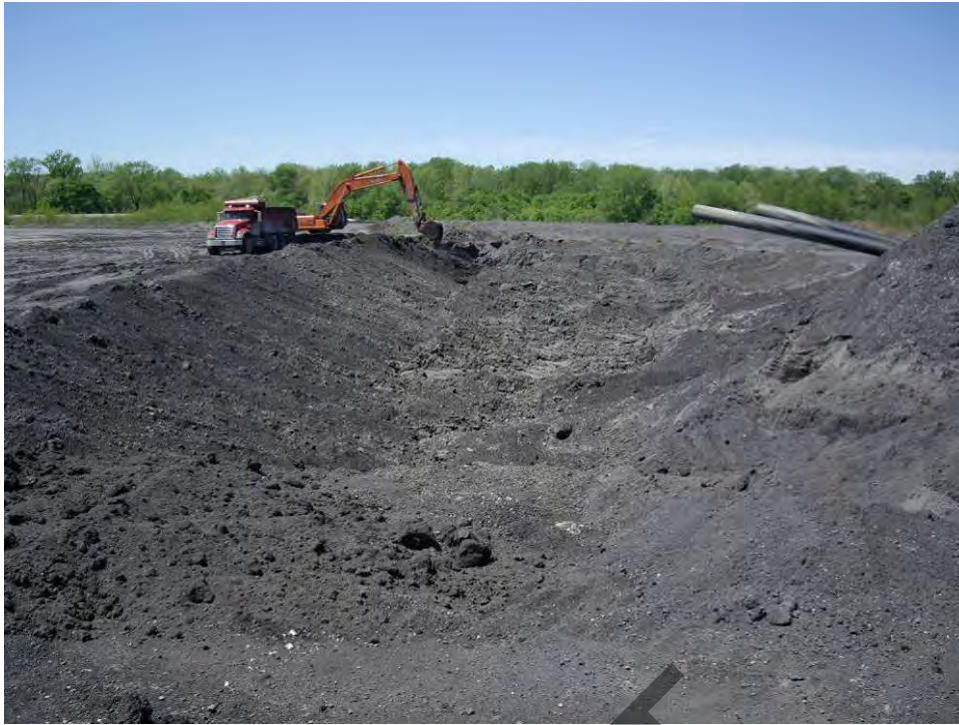
11. Overview of ash excavation in Pond A looking west. Ash being used as fill to repair Ponds D and E..

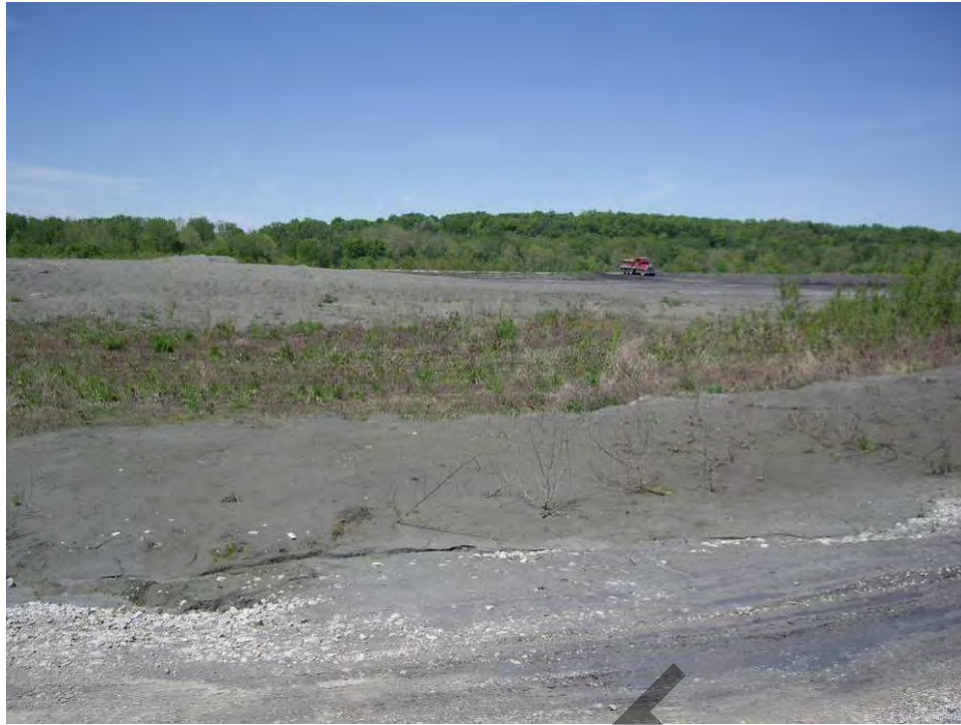
13. Overview of Pond A from crest of southeast corner looking northwest.

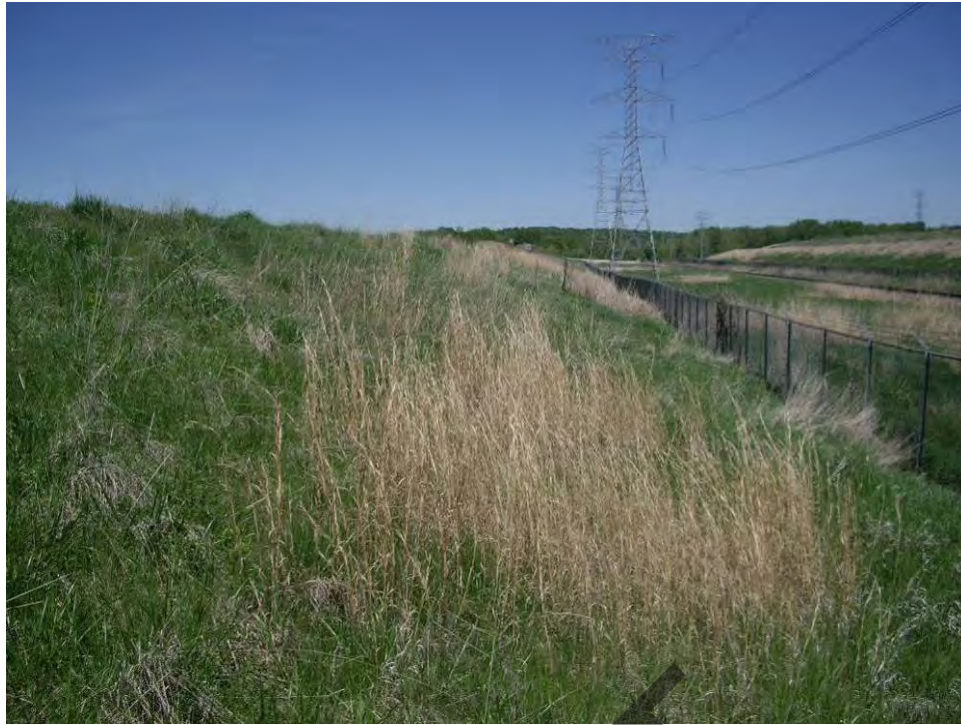
The exterior slopes of the Pond A embankments appear to be in fair condition. The exterior slopes on the north, south, east, and west embankments ranged from approximately 2.5H:1V to 3H:1V (Photos 1, 15, 20, 23, 25, 45, and 46). The exterior slope on the embankment between Pond A and Pond B (divider embankment A/B) and embankment between Pond A and Pond C (divider embankment A/C) ranged from approximately 2H:1V to 3H:1V (Photos 28, 33, 34, 38, 40, and 42).

15. Pond A – East embankment exterior slope looking north.

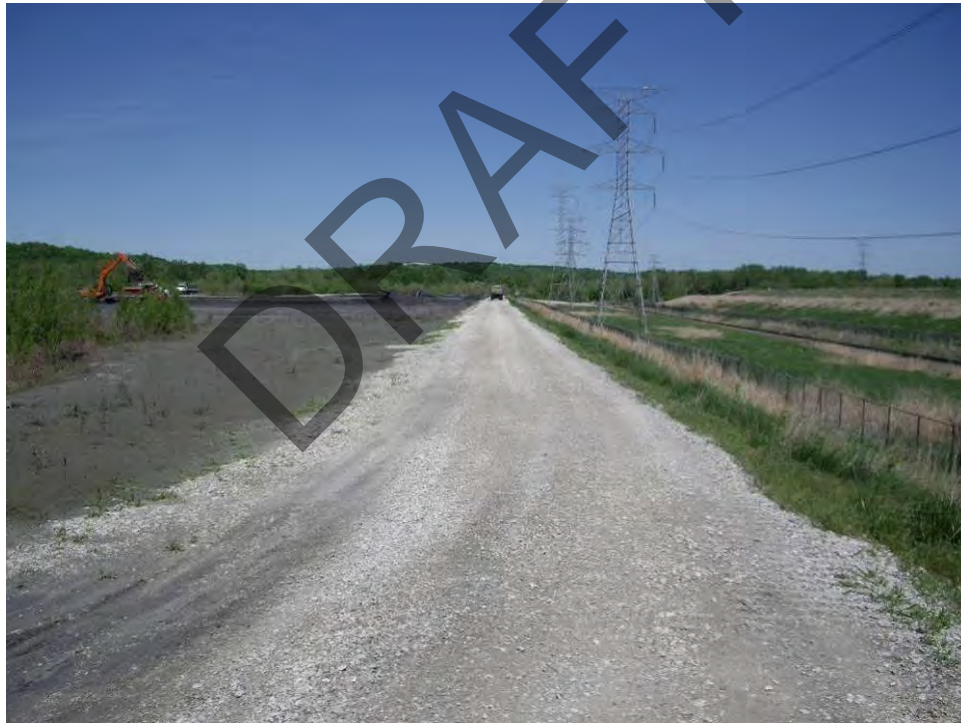
The crest of the Pond A embankments appeared to generally be in fair condition (Photos 2, 8, 14, 16, 19, 22, 24, 27, 30, 34, 43, and 44). The crest was approximately 15 feet wide with exception of the truck turn around area where the crest was significantly wider. The crest consists of a compacted gravel access road around the perimeter. Three low spots were observed in the crest (Photos 2, 14, and 28). Two of the low spots appear to be from recent truck traffic rutting the crest. The low spot on the east embankment observed on 4/28/10 was filled in by IPL personnel by 4/29/10. IPL indicated that the low spot on the divider embankment near the outlet pipes (Photo 28) is an overflow spillway. There are no records in the information provided to CDM to indicate this was a design feature. There were no deficiencies observed in this area.

16. Pond A – East crest looking north.

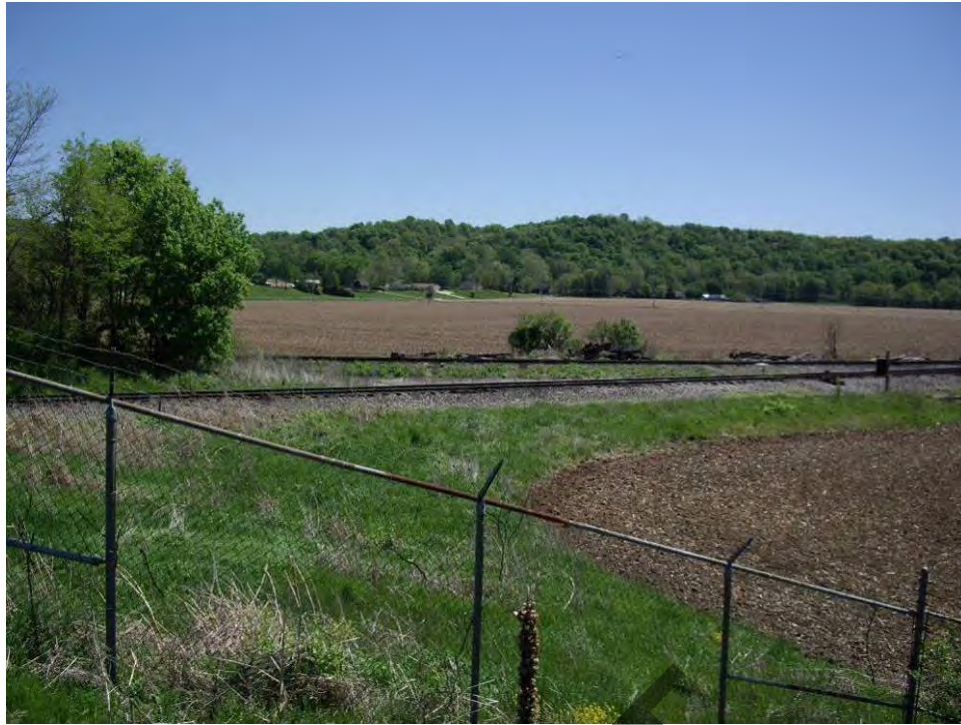
17. Pond A – Downstream area of east embankment looking southeast.

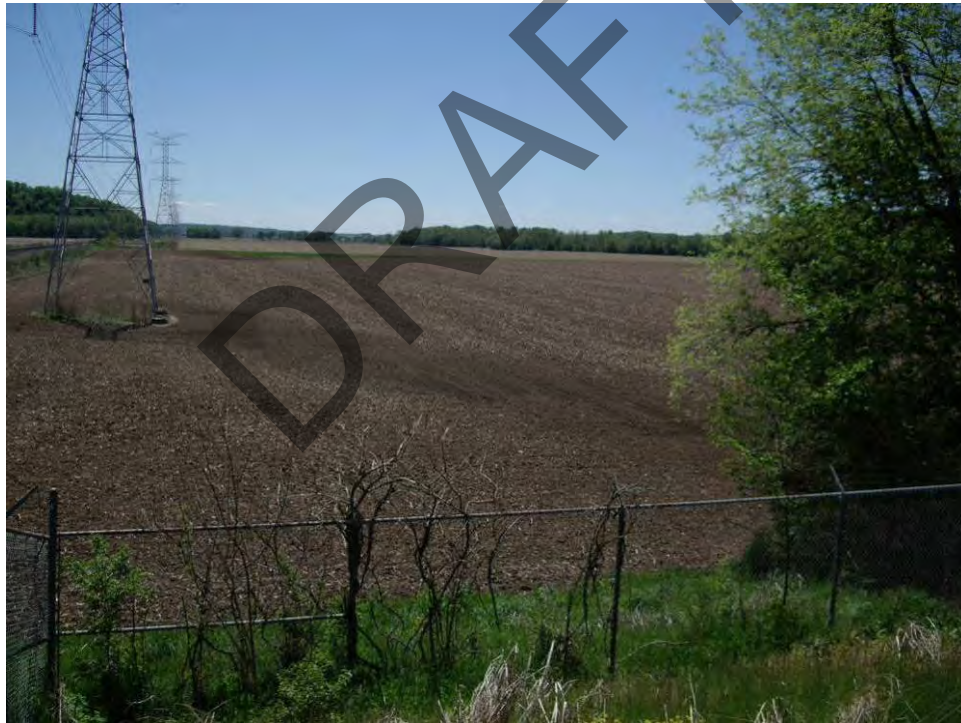
18. Pond A – Downstream area of east embankment at southeast corner of embankment looking south.

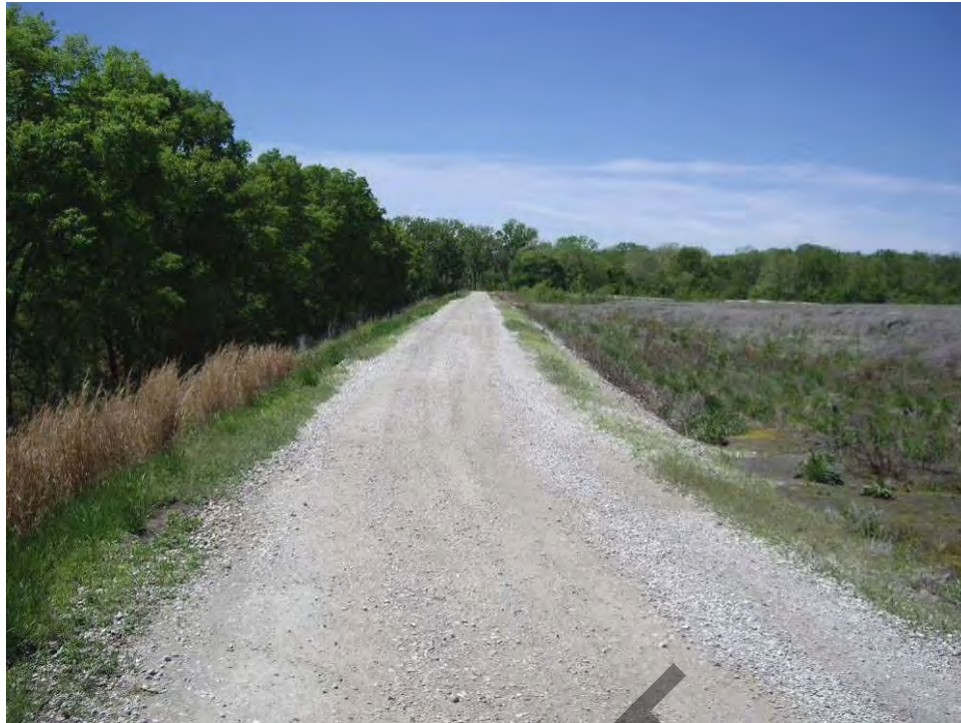
19. Pond A – South embankment crest looking west.

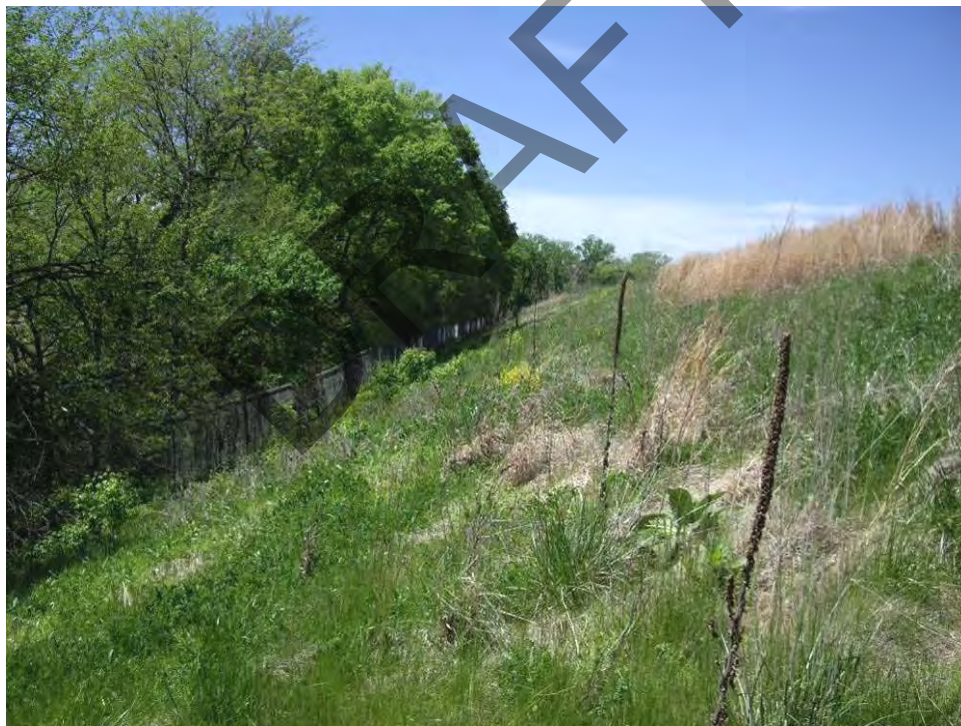
20. Pond A – South embankment exterior slope looking west.

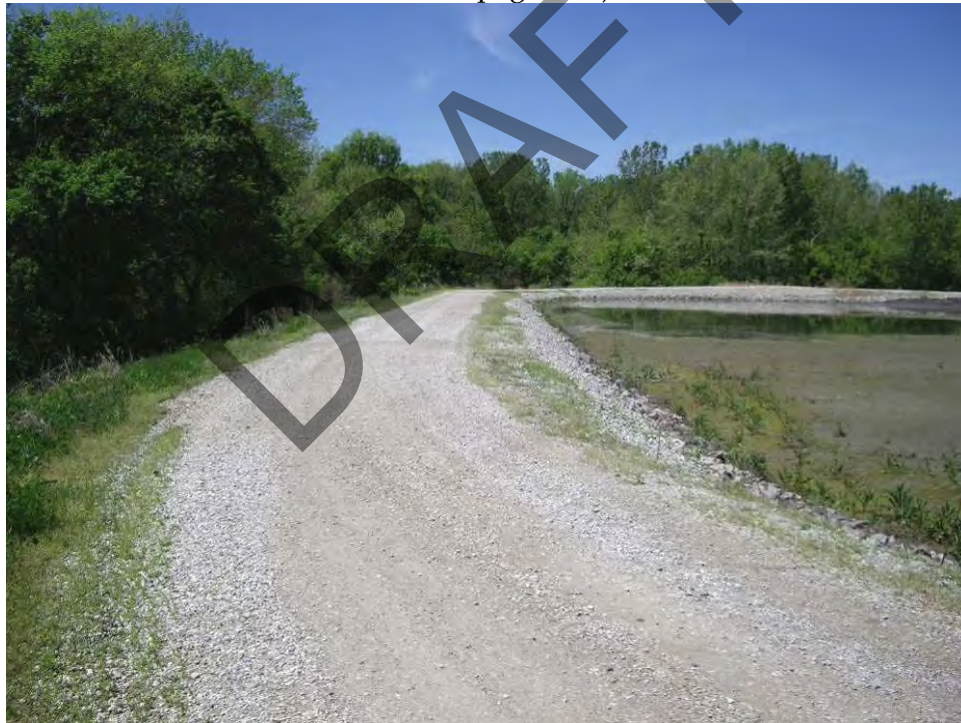
22. Pond A – South embankment crest, looking west.

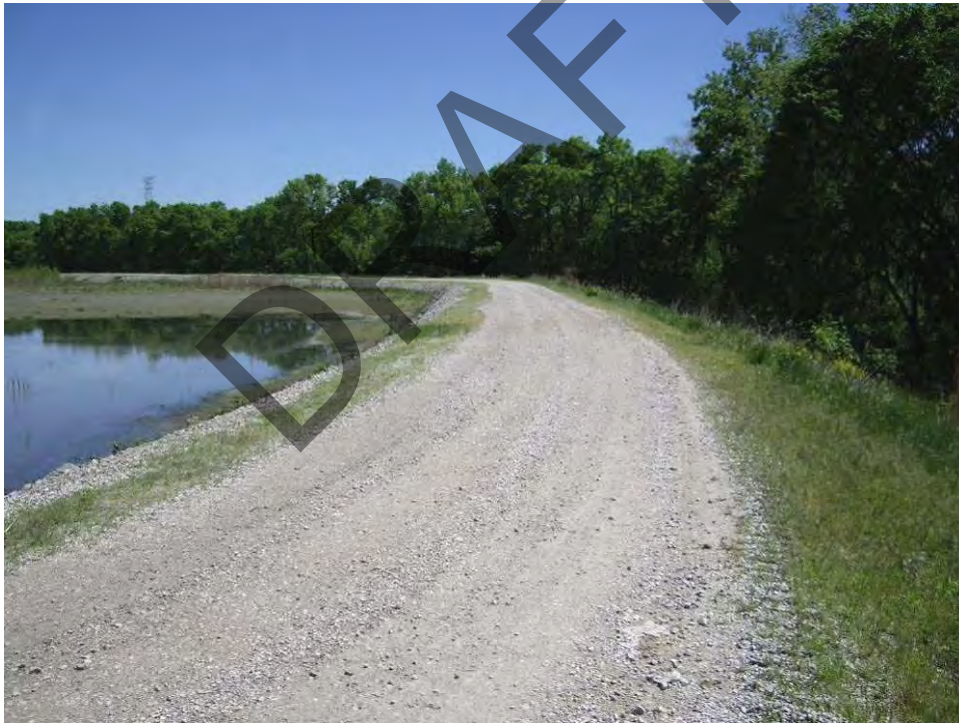
24. Pond A – South embankment crest, looking southeast.

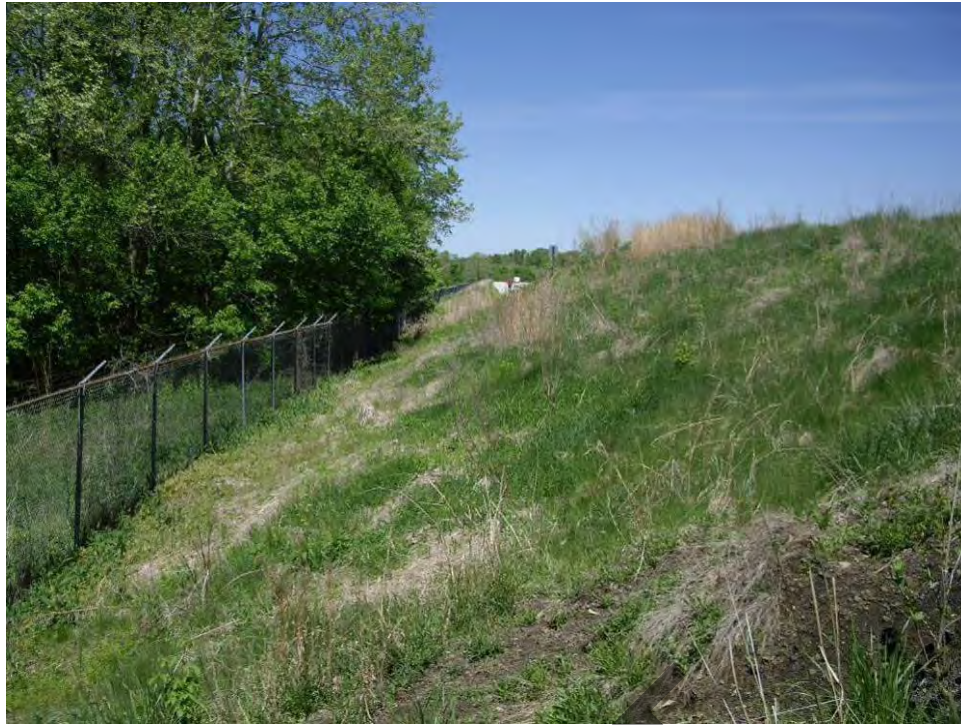
25. Pond A – West embankment exterior slope, looking north.

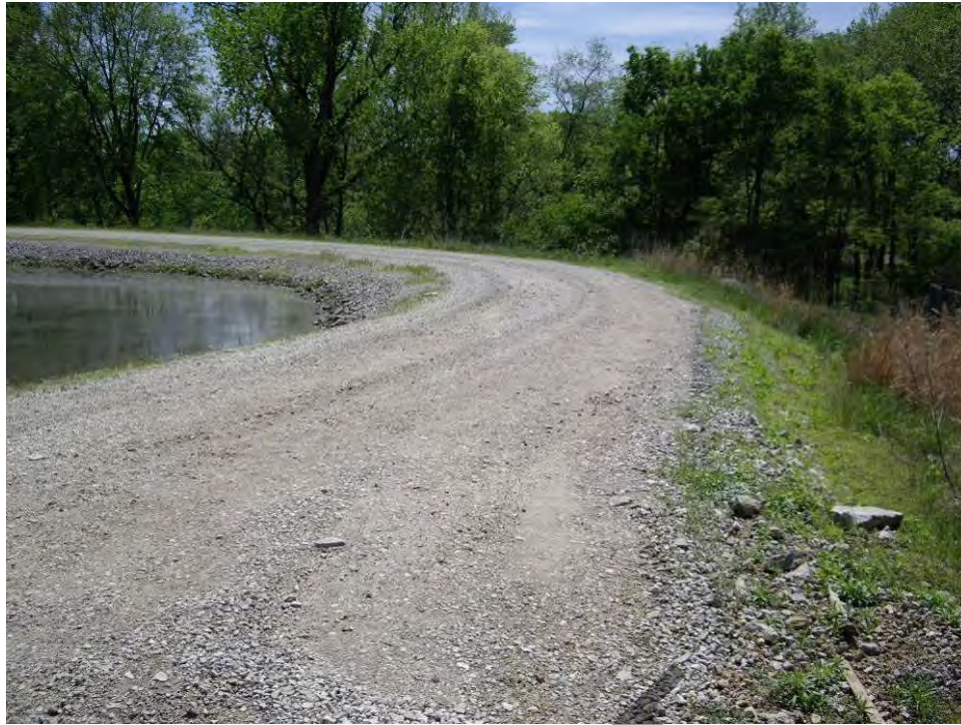
27. Pond A – West embankment crest, looking south.

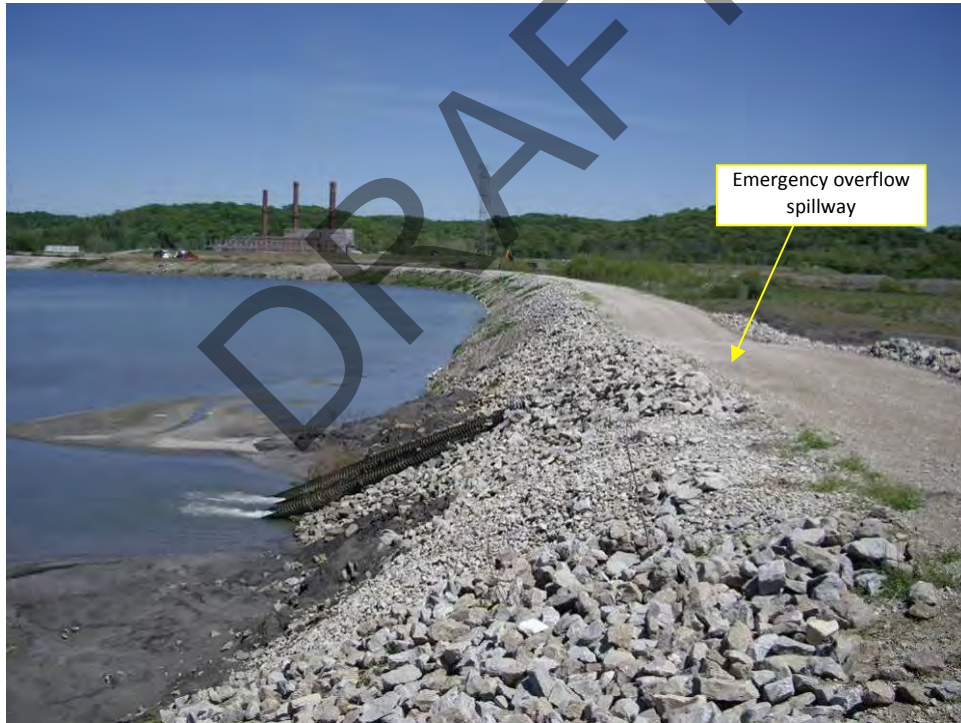
28. Pond A/B – north slope of divider embankment, looking east.

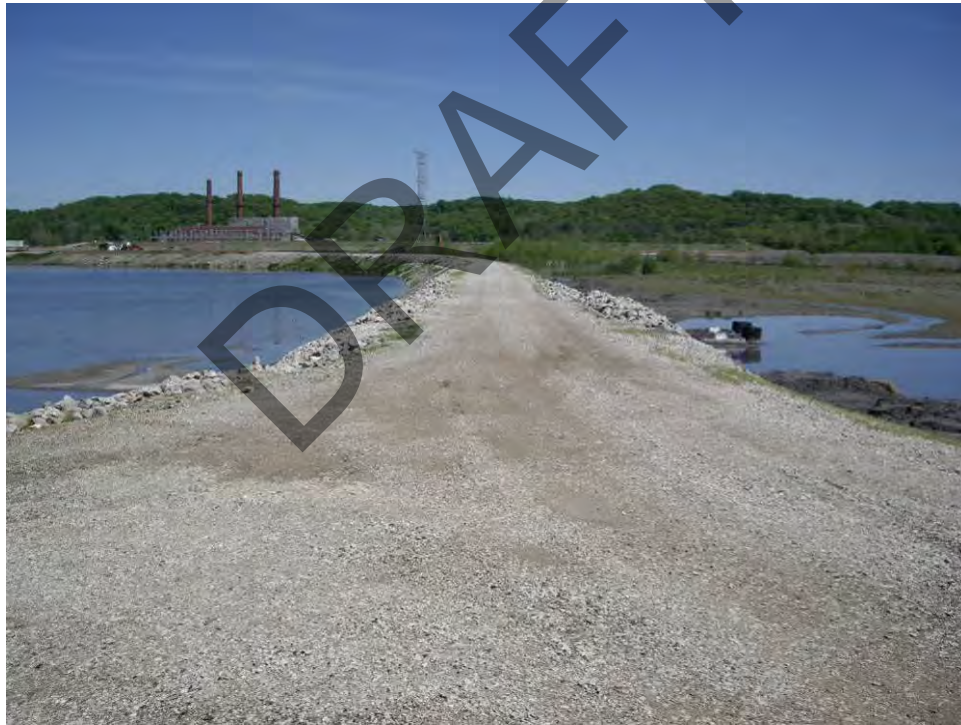
30. Pond A/B - crest of divider embankment, looking east.

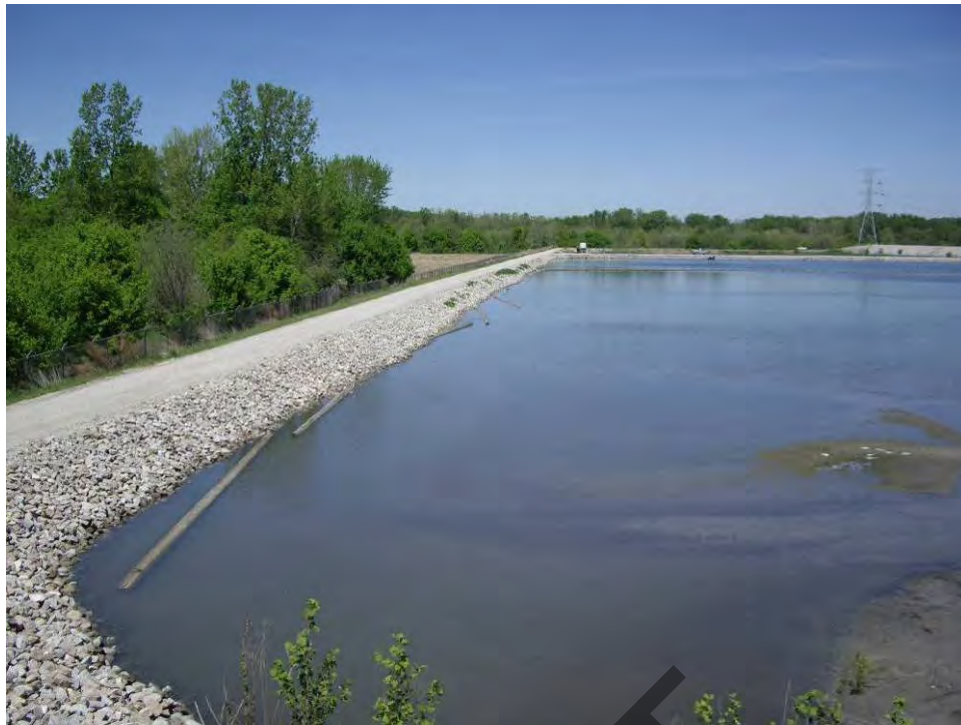
31. Overview of Pond B & C from crest of Pond A, looking northeast.

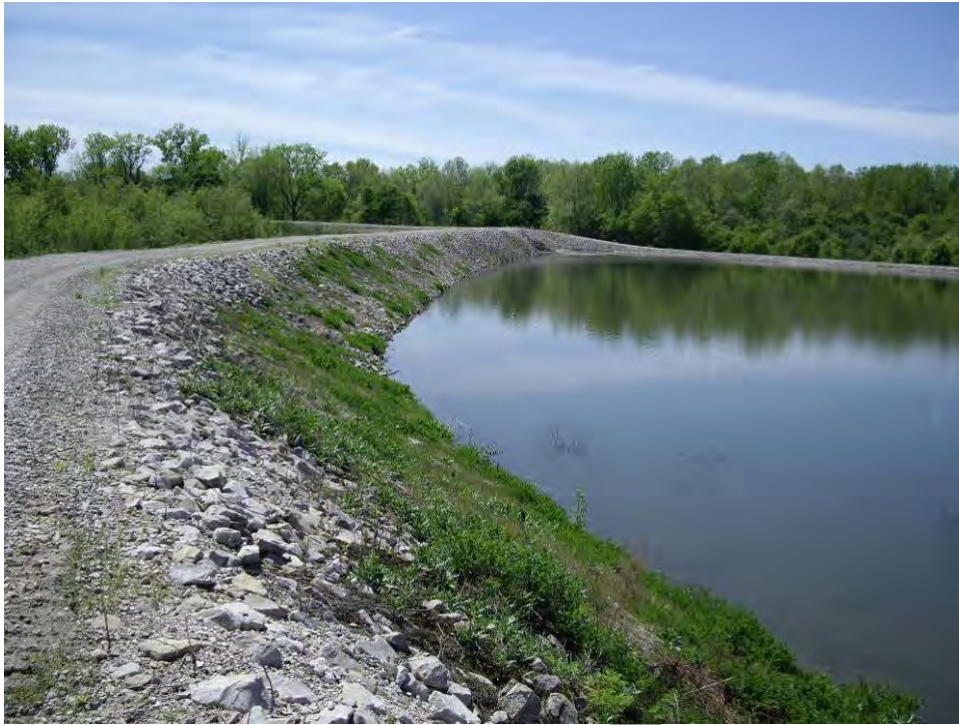
33. North slope of divider embankment A/B and Pond B west embankment, looking southwest.

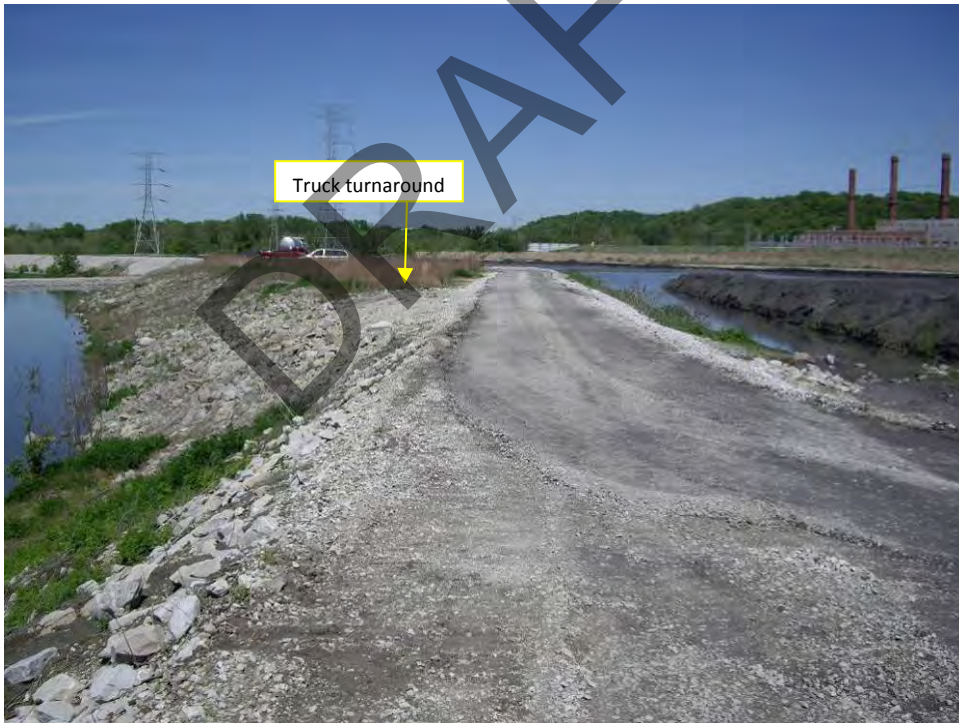
34. Crest of divider embankment A/B, looking northeast.

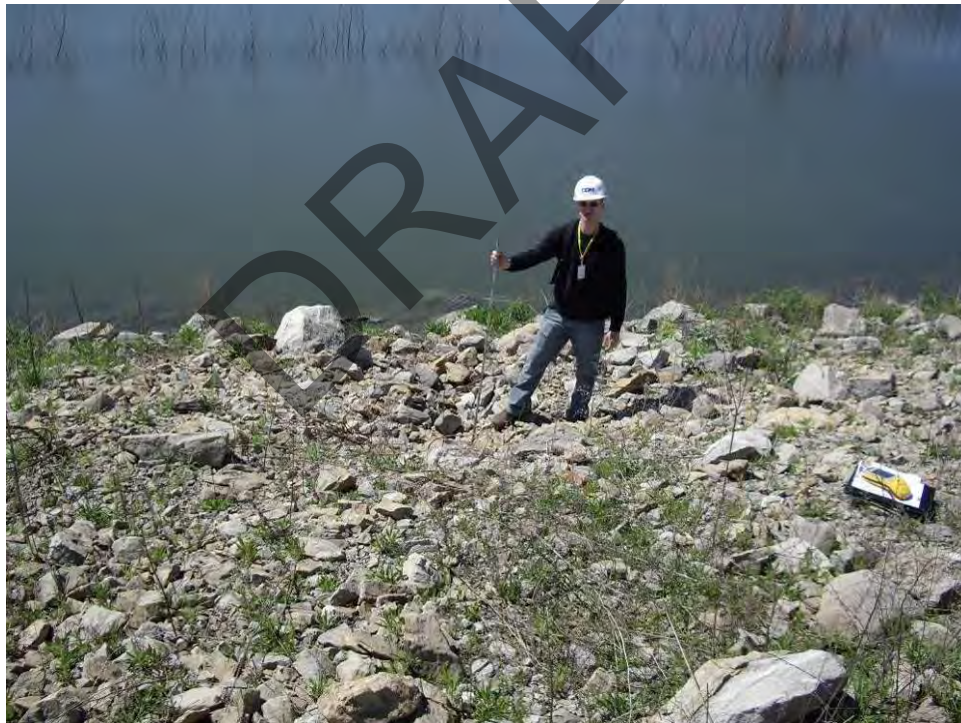
36. Depression in north slope of divider embankment A/B.

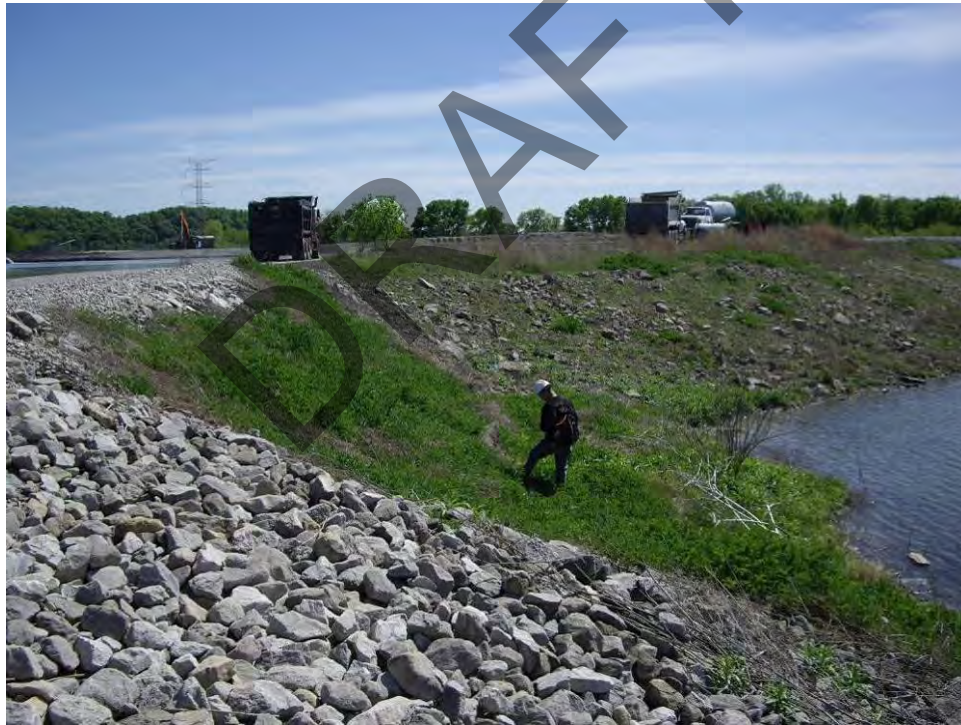
38. Northwest slope of divider embankment A/B, looking south.

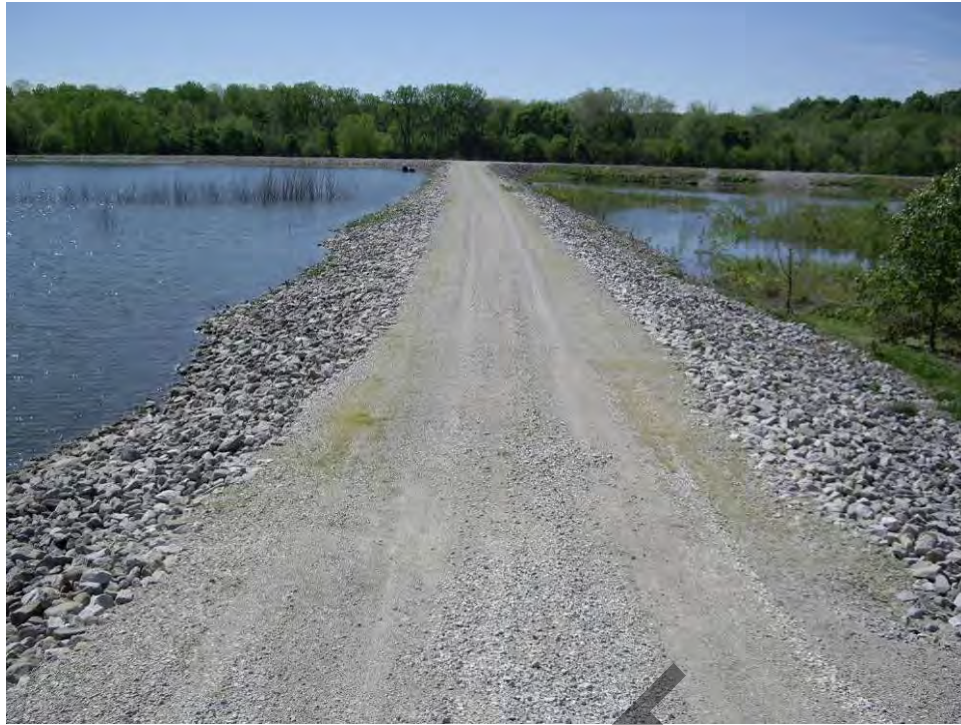
39. Crest of divider embankment B/C from crest of Pond A, looking west.

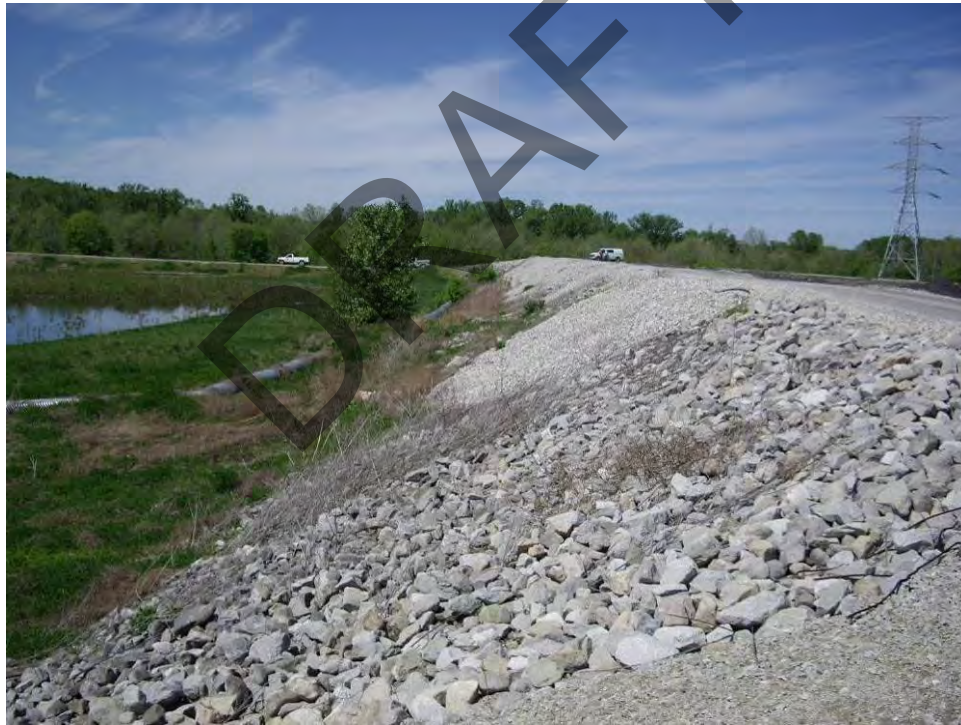
40. West slope of divider embankment A/C from Pond B, looking north.

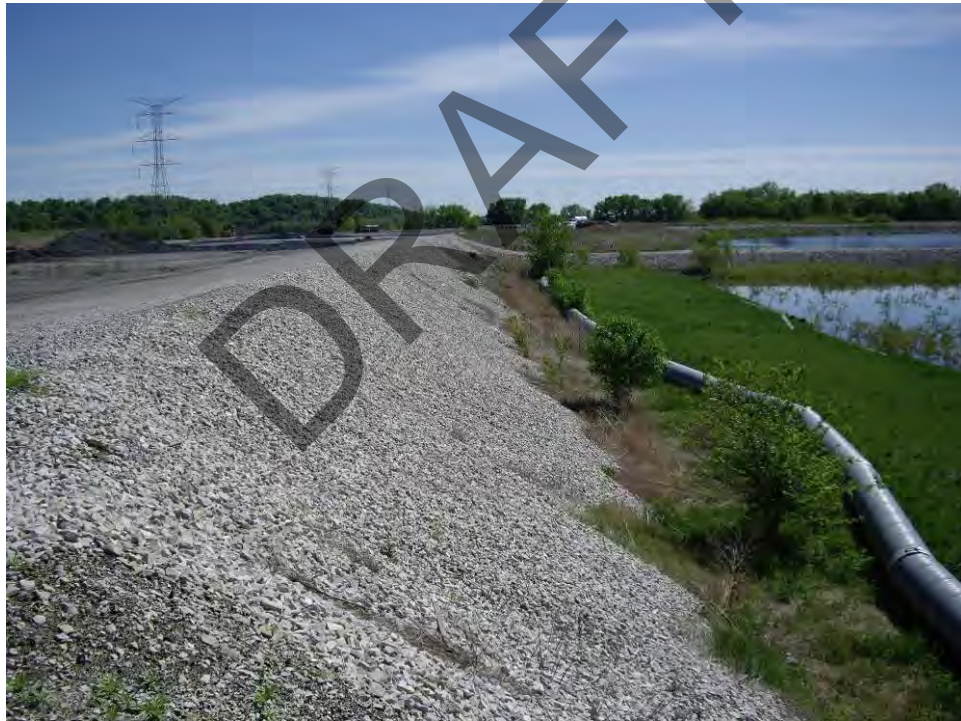
42. West slope of divider embankment A/C from Pond C north embankment, looking south.

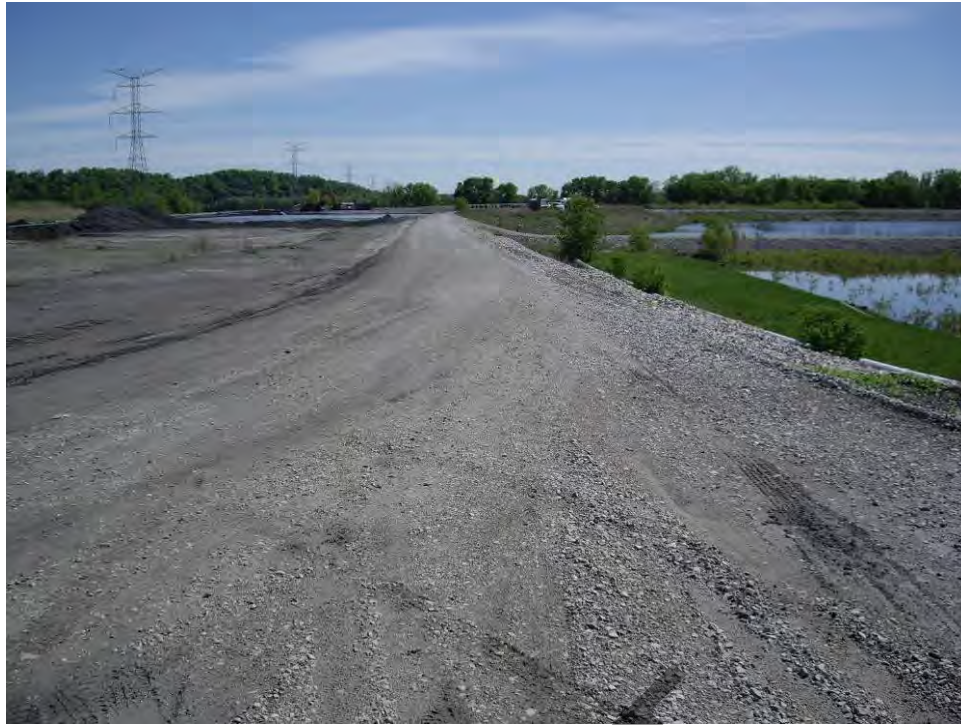
43. Crest of divider embankment A/C from Pond C north embankment, looking south.

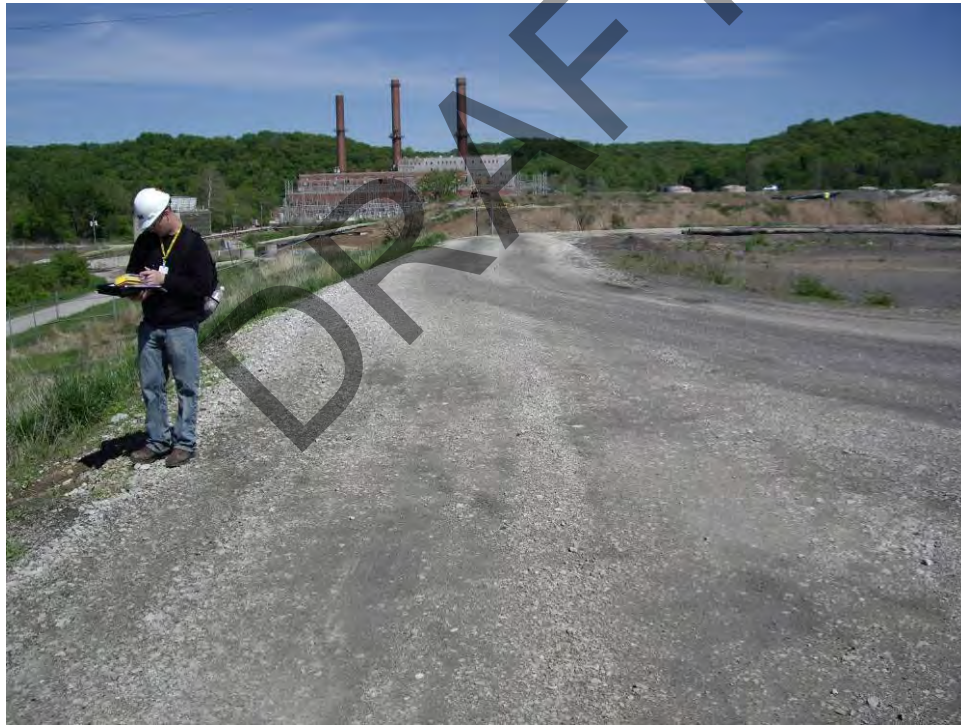
44. Pond A – North embankment crest, looking east.

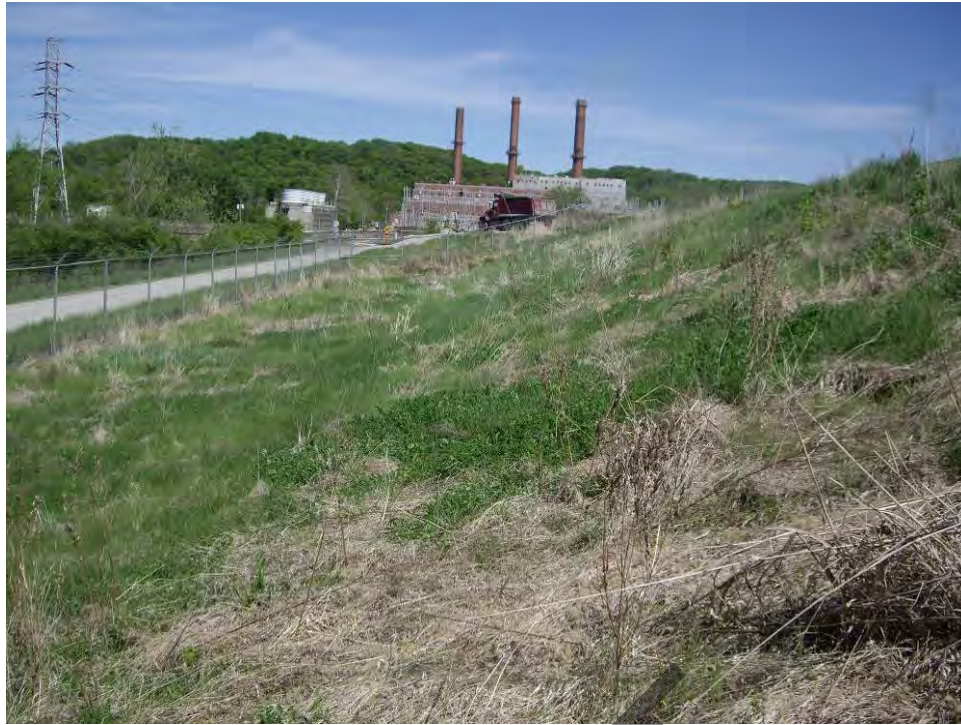
45. Pond A – North embankment exterior slope, looking east.

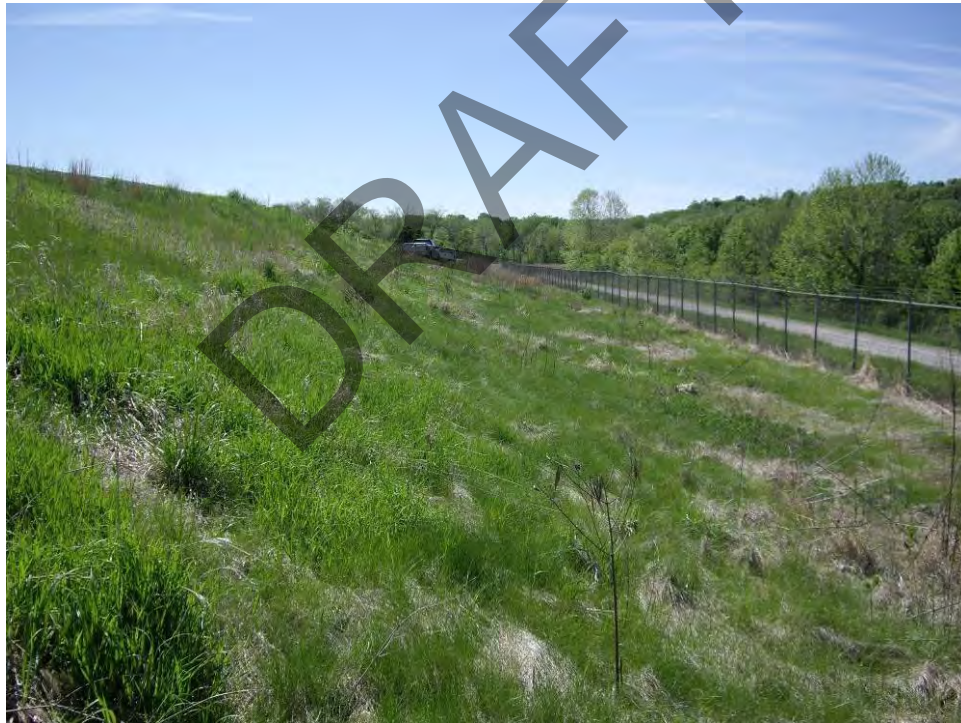
46. Pond C – North embankment exterior slope, looking west.
